LatticeMico32 Migration Concerns Post ispLEVER 8.1 and Diamond 1.0

November 2010 Technical Note TN1221

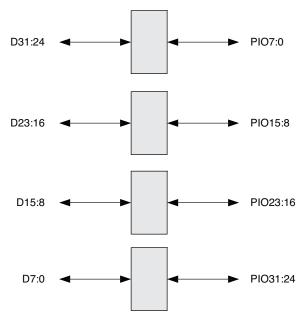
Figure 3. ispLEVER 8.1 SP1/Diamond 1.1 and Later

Another change that has been made is to explicitly describe which port I/O pin is controlled by each byte within the register. The new definition provides an addressing order that is friendly to an 8-bit Wishbone master. This has a side effect for the LatticeMico32. The side effect is to swap the port I/O bytes relative to the LatticeMico32's preferred big endian format. This is illustrated in Figures 2 and 3.

There are a couple of options open to system designers to handle the change in the GPIO's new behavior.

- The LatticeMico32 platform developer can place a top-level HDL wrapper around the Verilog code generated by LatticeMico32 System Builder.
- The C/C++ firmware developer can update the code that accesses the GPIO registers.

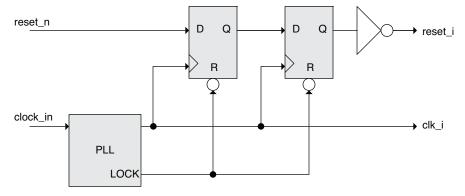
Figure 7. Example reset_i Controller

After restoring the PLL in the wrapper it is recommended that a circuit to manage *reset_n* be implemented. LatticeMico32 platforms clocked by a PLL operate best when *reset_n* is released after the PLL reports that it has locked to the input frequency. One possible solution is shown in Figure 7.
